Geologic Maps Identify Post-Wildfire Hazards

Vince Matthews (Colorado Geological Survey)
and David Gonzales (Fort Lewis College)

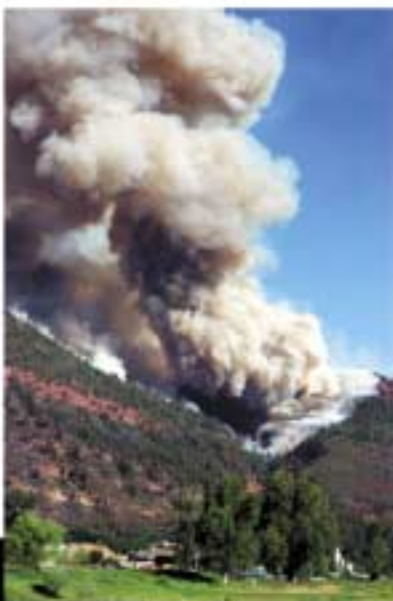
Fig. 1.
Homeowners
and emergency
managers are
still coping with
debris flows and
the aftermath
of the 2002
Missionary Ridge
wildfire near
Durango, CO.

Wildfires, such as the Missionary Ridge fire that burned for more than a month in 2002 near Durango, Colorado (Fig. 1), and their **aftermath** can cause subsequent property and environmental damage. Many areas denuded by the **fire** are now susceptible to **rapid erosion** during heavy precipitation with resulting debris flows, or “mudslides.”

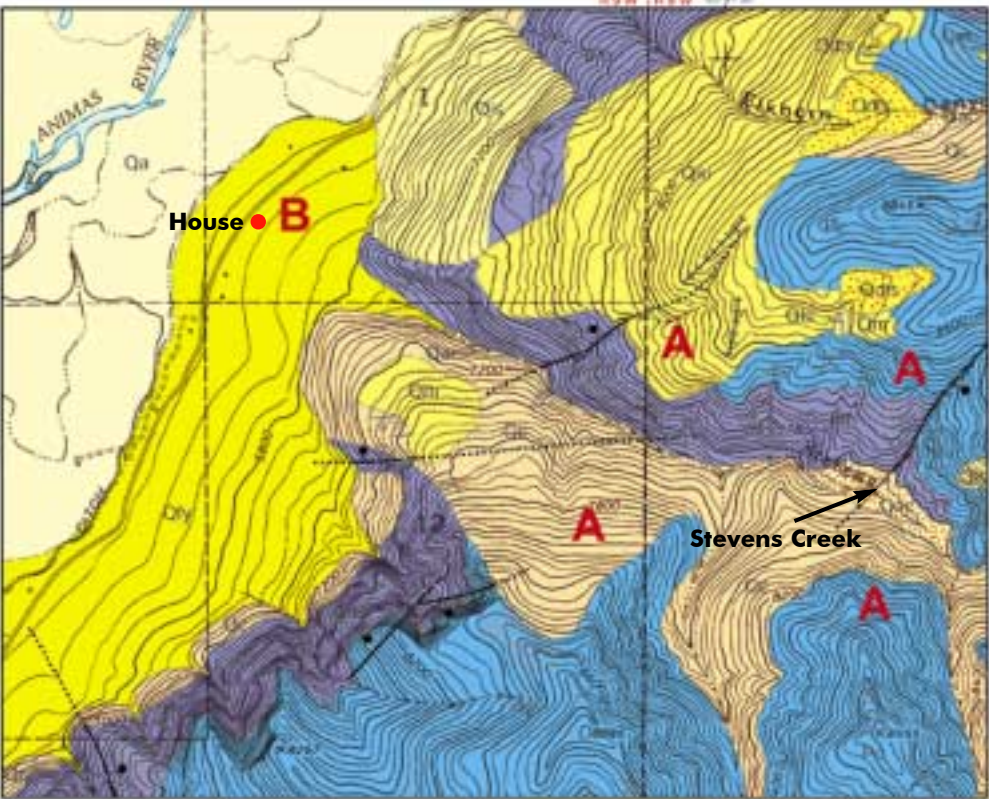
Fig. 2. This part of the Hermosa geologic quadrangle map covers the burn area around Stevens Creek. The darker yellow pattern (Qfy) shows debris fans mapped in 2001. The fan marked B at the mouth of the creek suffered major debris flow activity after the Missionary Ridge fire (Fig. 3). Units particularly susceptible to erosion are the glacial moraine (Qm, A), colluvium (Qc, A), and Cutler Formation (Pc, A).

Geologic maps are tools for **evaluating** post-fire, debris-flow **hazards**. The geologic map (Fig. 2) shows the distribution of rock types and surface deposits in relation to topography. The darker yellow pattern (Q_{fy}) shows the location of alluvial fans created by historic **debris flows**. The areas most susceptible to post-fire erosion are the glacial moraine (Q_m, A), colluvium (Q_c, A), and Cutler Formation (P_c, A).

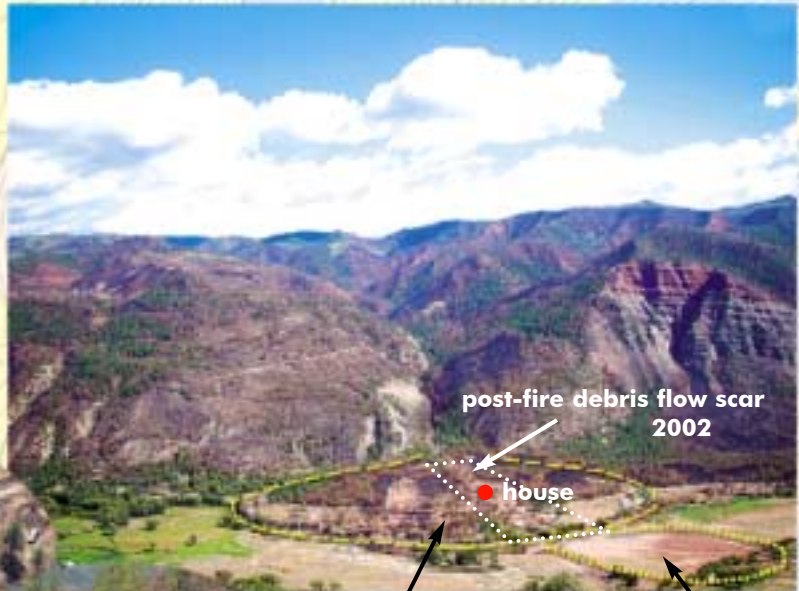
Fig. 3. Aerial view looking up Stevens Creek at burn area of the 2002 Missionary Ridge wildfire and the debris fan at the mouth of the creek. After the fire, the house, which was built on an ancient debris fan, was engulfed by a debris flow (see map and photos).

Mapping in 2002 shortly after the fire **revealed** a sequence of older debris flows exposed in the incised channel of a modern, fire-induced debris flow that formed after the Missionary Ridge fire (Fig. 3). Associated charcoal layers dated by C14 methods showed a record of **repeated** fire followed by debris flows extending back 4300 years. The cycles of major fires in the Durango area correlated well with a fire sequence established in Yellowstone National Park, hinting at a broader geographic extent of repeated wildfires and debris flow **events**.

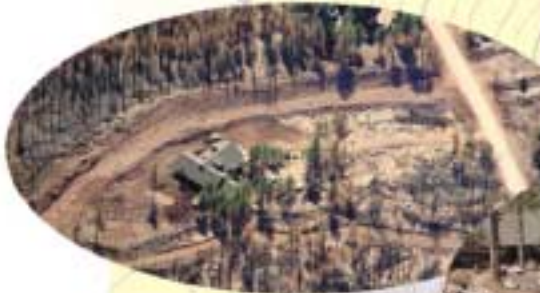
house after fire in 2002

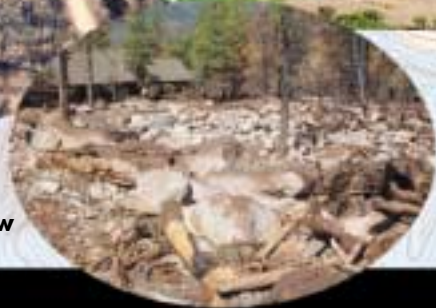
house engulfed by post-fire debris flow
