North Dakota

Geologic Map Guides Transportation Planning

Edward C. Murphy (North Dakota Geological Survey)

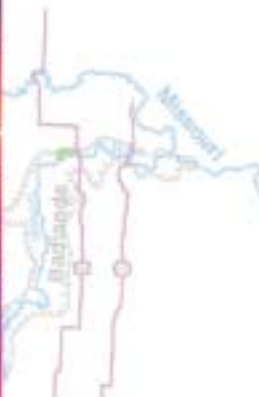
Fig. 1. Two recent landslides impacting ND Highway 22 along the south edge of the Little Missouri River Valley. It cost \$2 million to stabilize the area and realign the road.

U.S. Highway 85 and ND Highway 22, along with numerous county roads, buildings, pipelines, and power lines, have been constructed over existing landslides in the Little Missouri Badlands of western North Dakota. Since 1980, the **repair** and **rerouting** of damaged sections of **highways** in this area have **cost taxpayers** more than \$5 million (Fig 1). In one instance, a one-mile segment of U.S. Highway 85 was rerouted from one area of landslides into another. Better understanding of landslide hazards is needed in this area.

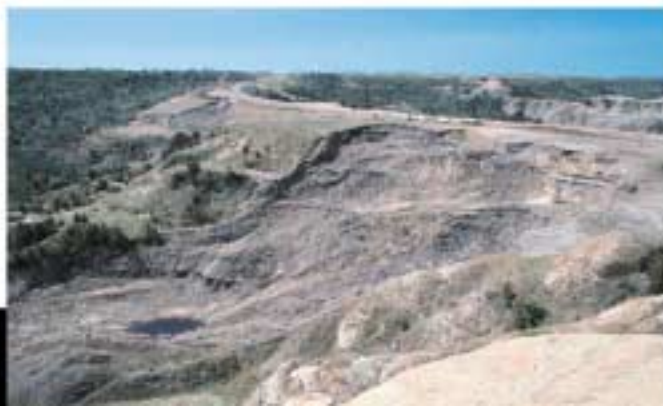
geologic map

The geologic map encompasses an area of 125 square miles adjacent to the North Unit of Theodore Roosevelt National Park (Fig. 2). In customizing the **map** for use by design engineers, land planners, and developers, several Quaternary river deposits (gray, Qal), were lumped together to make the **landslides** (pink, Ql), stand out more clearly. In addition, the geologic units were draped over a shaded-relief background to further emphasize the relationship between the landslides and the surrounding topography.

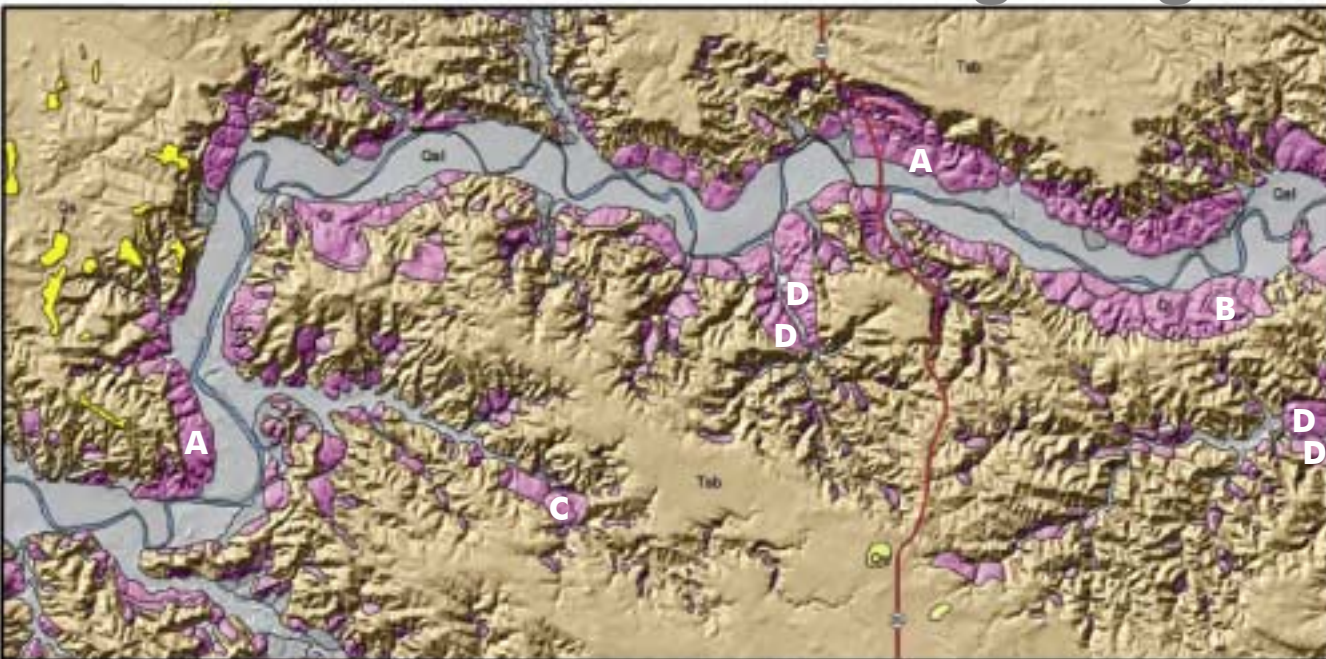
Fig. 2. In the region where U.S. Highway 85 crosses the Little Missouri River Valley, alternating beds of sandstone, siltstone, claystone, mudstone, and lignite in the Sentinel Butte Formation (Paleocene) are the dominant rock units. Landslides are most prevalent along the sides of the Little Missouri River Valley (A), and landslide complexes may extend for more than five miles (B). Landslides occur throughout the extent of the adjacent drainages including the heads of ravines (C). Landslides do not appear to have occurred preferentially on specific slopes such as east-west or north-south (D). Thin deposits of sand and gravel (Qs) and windblown silt (Qw) are present in the uplands.

Approximately 37% of the slopes in the **badlands** in and around the North Unit of the Theodore Roosevelt National Park have failed, and 700 landslides, covering an area of 15,000 acres (6,070 hectares), were identified and mapped in the study area. (Since many of these slides are large complexes, as much as 660 acres (267 hectares) in area, the total number of individual landslides is several times this number.) Most of the landslides are well vegetated, appear relatively stable, and are likely hundreds, if not thousands, of years old (Fig. 3). Without a geologic map showing the location of landslide topography, it is practically impossible for a non-geologist to recognize where there may be a problem. The high percentage of slopes that have failed in this area (1 in 3) demonstrates that the badlands **topography** is very **unstable**. Avoiding areas that have already failed will not guarantee that all slope-stability problems will be avoided, but should reduce the number of future impacts.

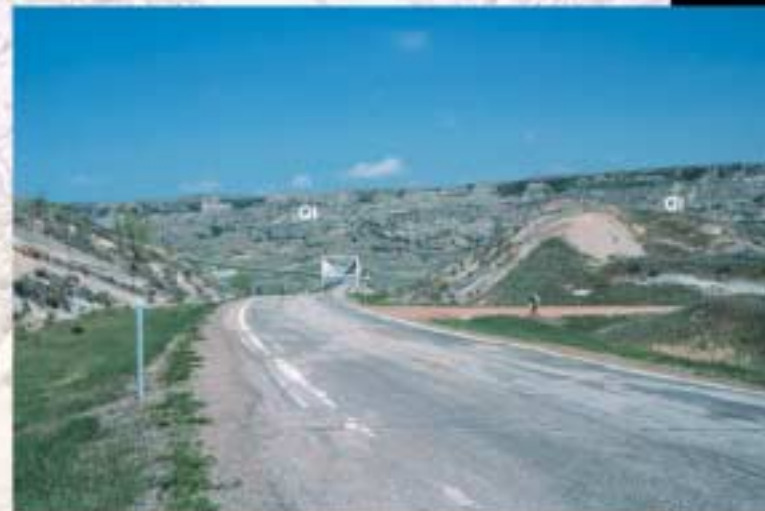
Fig. 3. U.S. Highway 85 crossing the Little Missouri River at Long X Bridge. Seventy-five percent of the rocks in this photograph, all of those in the foreground and the rocks along the north valley wall in the background (below the top of the Ql labels), have slid and are out of place.
